Manhole Inspection Summary

Manhole # S29E__010MH

Insp Date: **1/28/08 3:05 PM**

Location Address: **700 DR BENJAMIN QUARLES WAY** Cross Street: **SARATOGA ST**

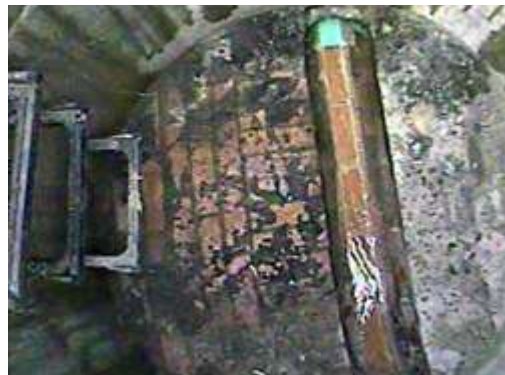
Top View

Comments **POSSIBLE INFLOW AT COVER.**

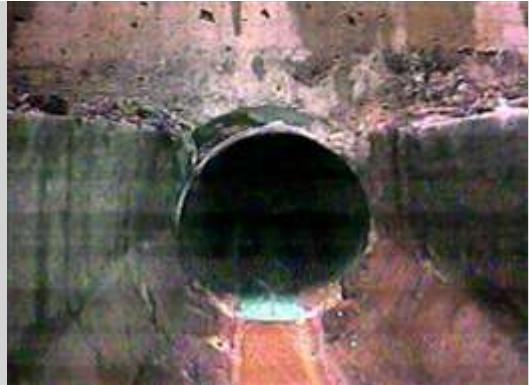
12 O'Clock Outflow

8 in. Circular Gravity Sewer
Pipe Out @ 12 O'Clock

Pipe Height: (in.) Direct
Pipe Material: **PVC** ☐ Pipe Lined
Invert Depth: **6.42** (ft.) Flow Characteristics: **Slow**
Deposits: ☒ None ☐ Mud ☐ Sludge ☐ Debris ☐ Grease
Silt Depth: (in.) Deposits Extent:
Infiltration: **None** Pipe Seal Cond: **Sound**

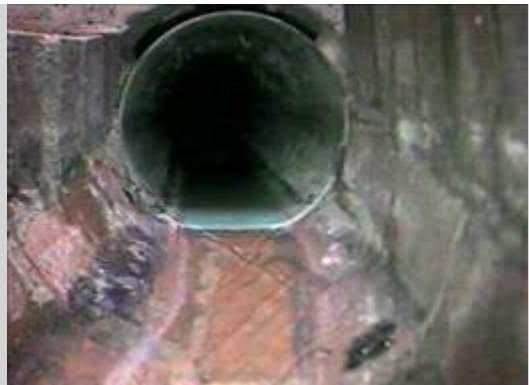
6 O'Clock Inflow

8 in. Circular Gravity Sewer
Pipe In @ 6 O'Clock

Pipe Height: (in.) Direct
Pipe Material: **PVC** ☐ Pipe Lined
Invert Depth: **6.22** (ft.) Flow Characteristics: **Slow**
Deposits: ☒ None ☐ Mud ☐ Sludge ☐ Debris ☐ Grease
Silt Depth: (in.) Deposits Extent:
Infiltration: **None** Pipe Seal Cond: **Sound**
